EnverBridge Abnormal Connection Issues & Solutions

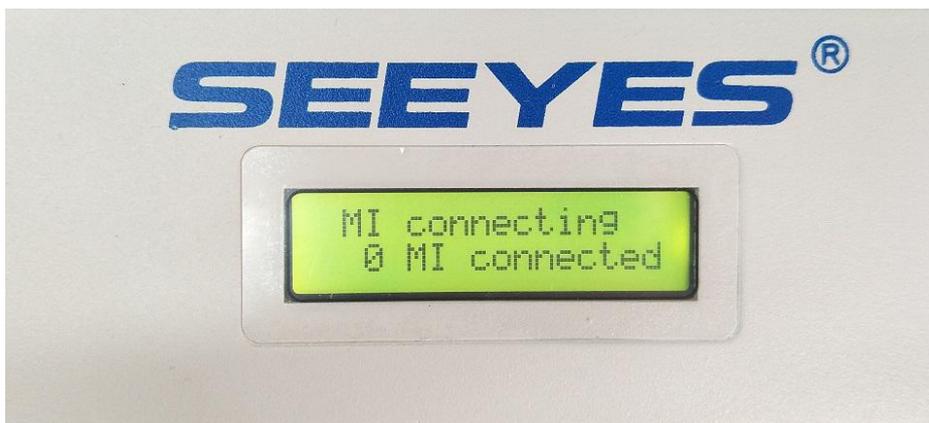
Case 2:

The display screen consistently shows “MI connecting” in the first line and “0 MI connected” in the second line.

This message indicates that EVB didn't receive any transmission signal from MI, the reason considering to be signal interference.

1、 Confirm whether the microinverter(s) monitored by this EnverBridge is(are) in normal conditions (with flashing green light).

2、 If the EnverBridge is Installed too far away from microinverter(s), the signal transmission would be too far to be effective. Try installing the EnverBridge nearer microinverter(s), better within 50m. The shorter the distance is, the better signal it would get.

3、 Check whether there is other special appliance causing interfering signal. When the EnverBridge is directly plugged into the wall outlet, avoid using other special appliances on the same line.
