EnverPortal Abnormal Issues & Solutions

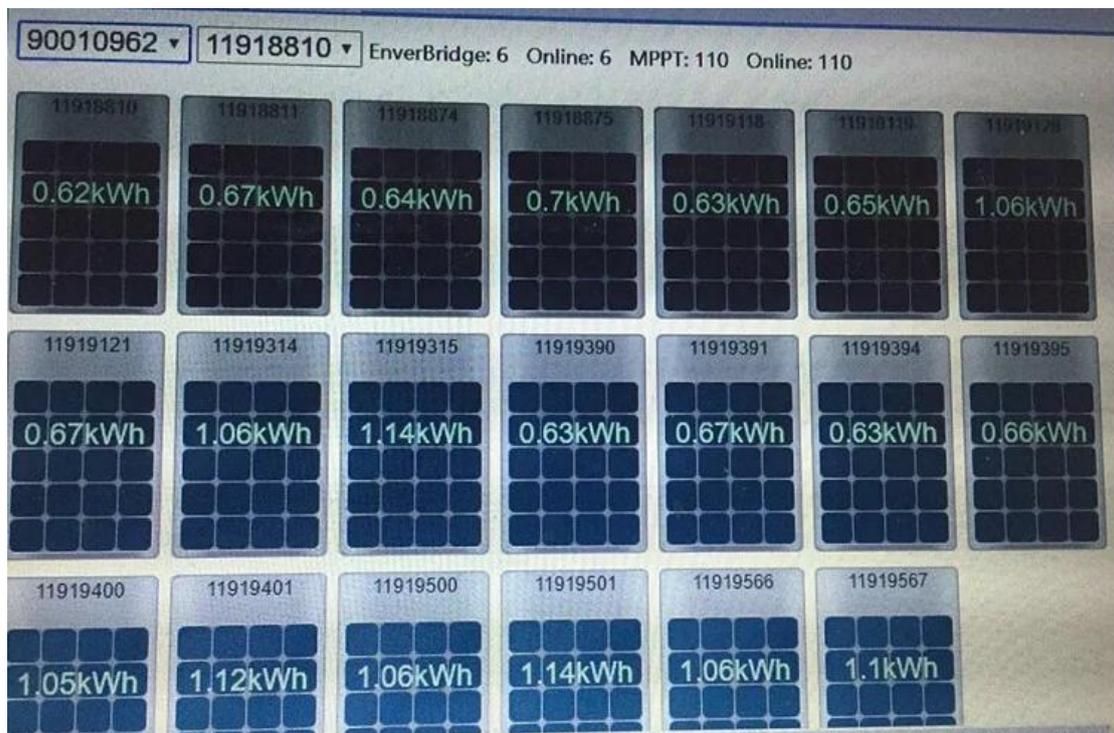
Case1:

Enverportal shows that several microinverters generate less energy than others, and stop uploading data prematurely.

First, any shade or grime on PV module should be removed.

If it doesn't help, please check whether these microinverters are working normally or it is a network problem. The steps are as follows:

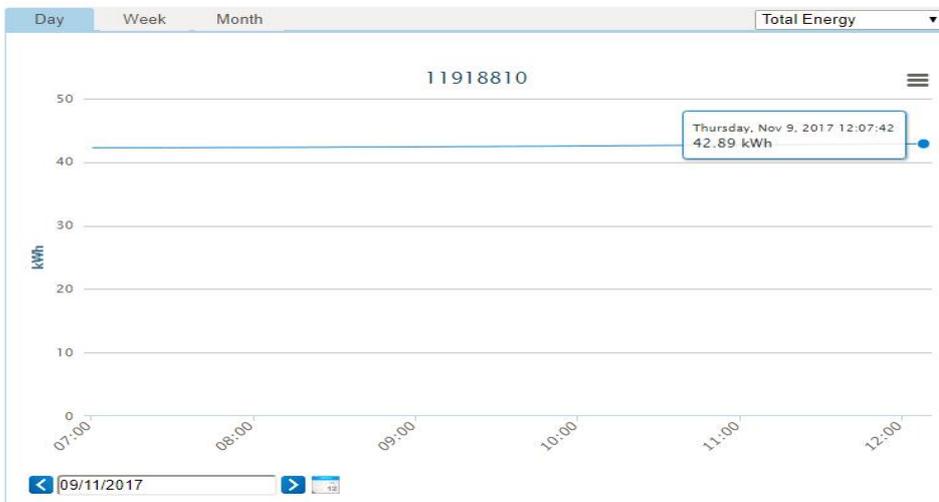
Click into one PV panel. Select Total energy parameter. Check the last energy output value of the first day. Here in Picture 1 it shows 42.89kwh at 12:07 on the 9th. Check the initial energy output value of the next day. In Picture 2 it is 43.31kwh at 6:46 am. The results show that the microinverter was generating electricity normally on the first day, but the network communication had some problem during a certain period of time.

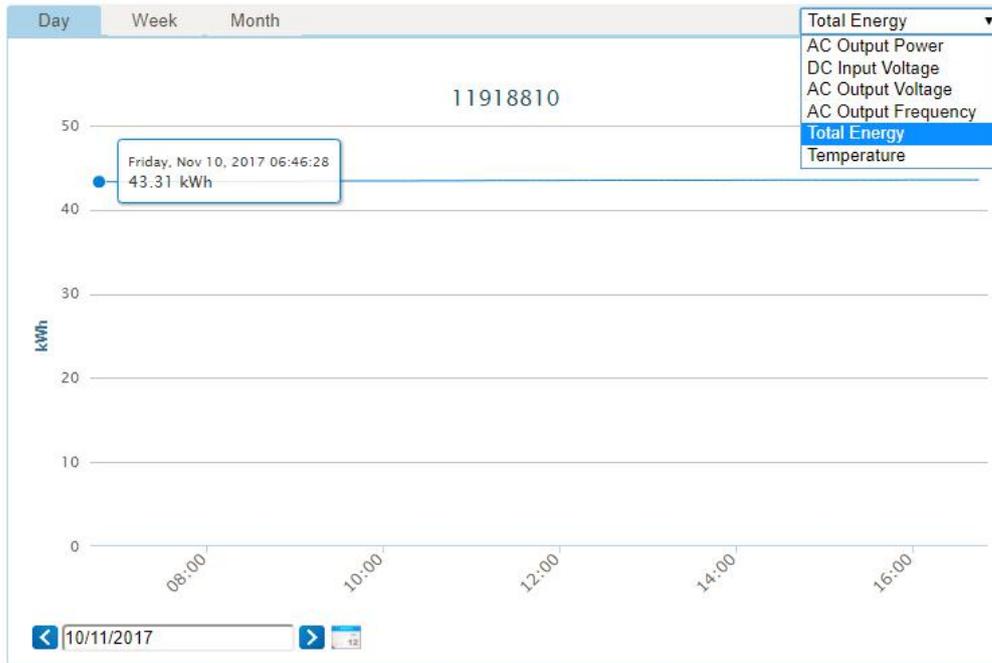
Picture 2

If the last energy output value of the first day and the initial energy output value of the next day are the same, then it means the microinverter was not generating power normally during that period.

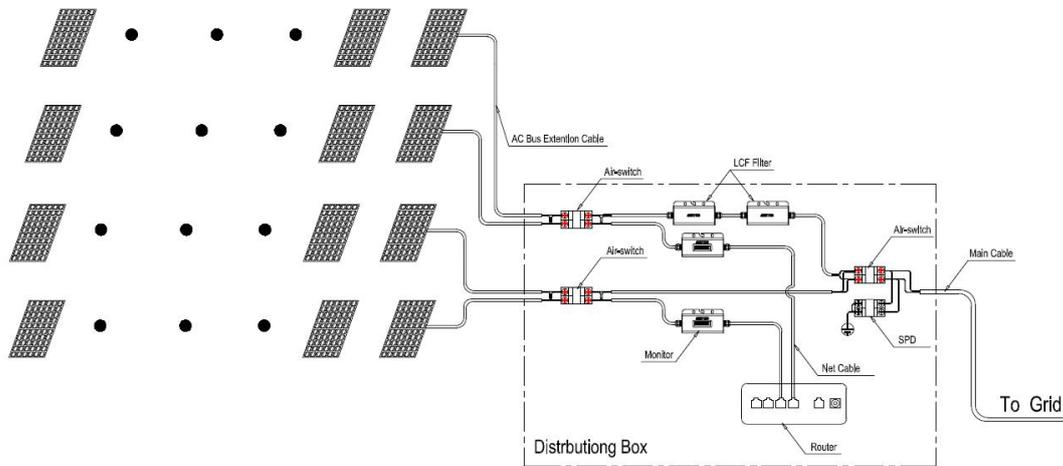
Incorrect wire connection

EnverPortal displays negative value in energy generation of one or more panels. Solution: This case may be caused by the incorrect wire connection in the PV power plant. The following wire connection can cause abnormal power generation:

The case above mainly occurs when the single-phase system has over 20 PV panels. The main reason is the signal interference between 2 EnverBridges, which causes the data uploaded by EnverBridge cannot be processed normally by the server, leading to the data abnormality displayed on EnverPortal or EnverView. The negative energy generation is one

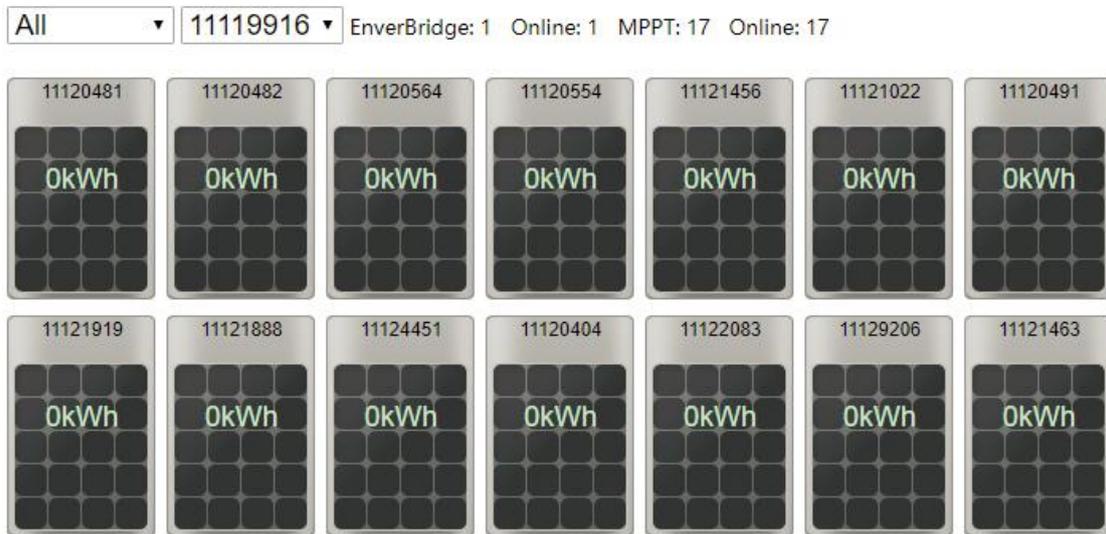
Case 4:

EnverPortal shows as below:

Solution: Please check if EnverBridge is correctly connected to the Internet. Refer to Appendix 1 in the next page for detailed procedures of

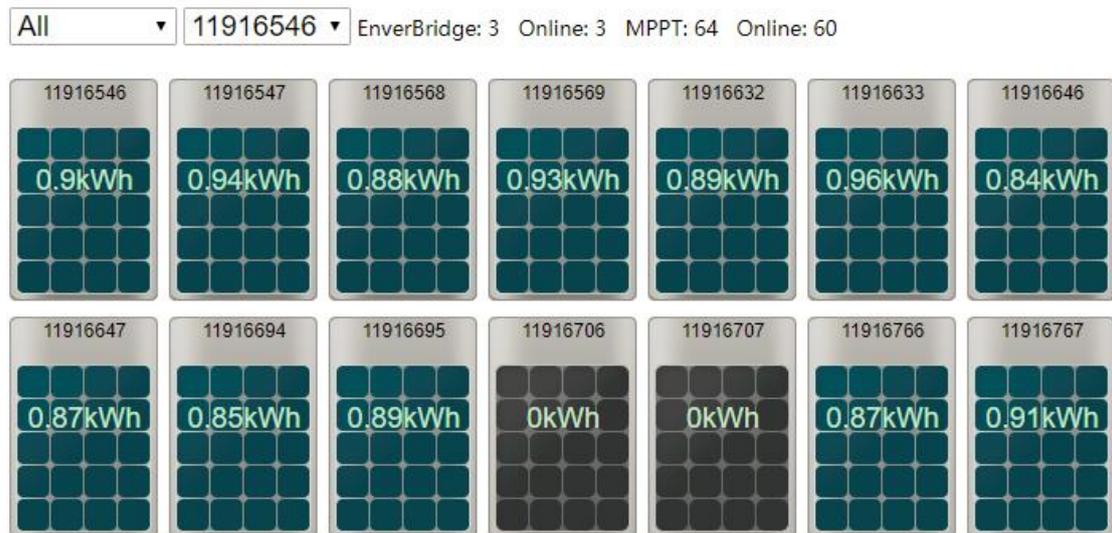
Case 5:

EnverPortal shows that some PV panels consistently generate 0 KWh.

First, if this inverter flash red light, please check whether the DC wire of PV panel is finely connected. Try disconnecting the DC wire and wait for 20 or 30 seconds. Then reconnect it.

Observe whether the green light flashes after 3 minutes. If not, please contact tech@envertec.com for more help.

If the green light is flashing, then the microinverter is working normally, please check the history report of that problematic microinverter.

If the problem only occurs on that day, it could be a sporadic communication fault. If the problem has lasted for a long time, it could be the malfunction of microinverter communication module, needing to change the microinverter (the old one can generate electricity but cannot be monitored).

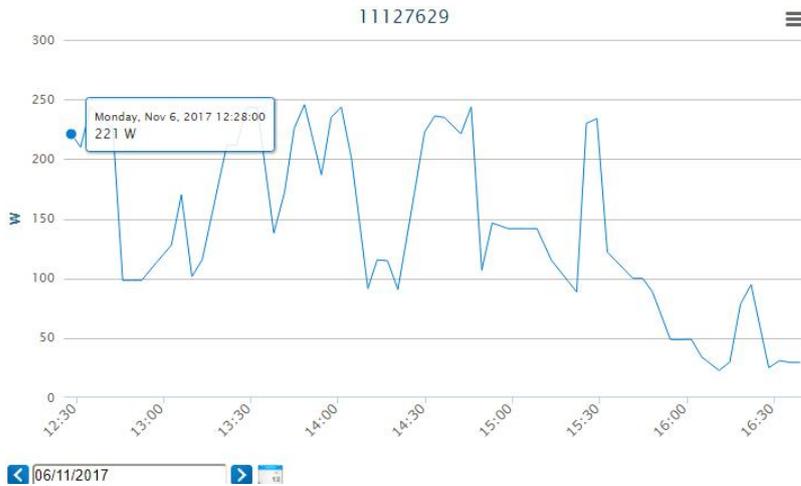
Case 6:

Data uploading starts later to make replacement.

Please check router settings and network conditions to see whether the router was not on before.

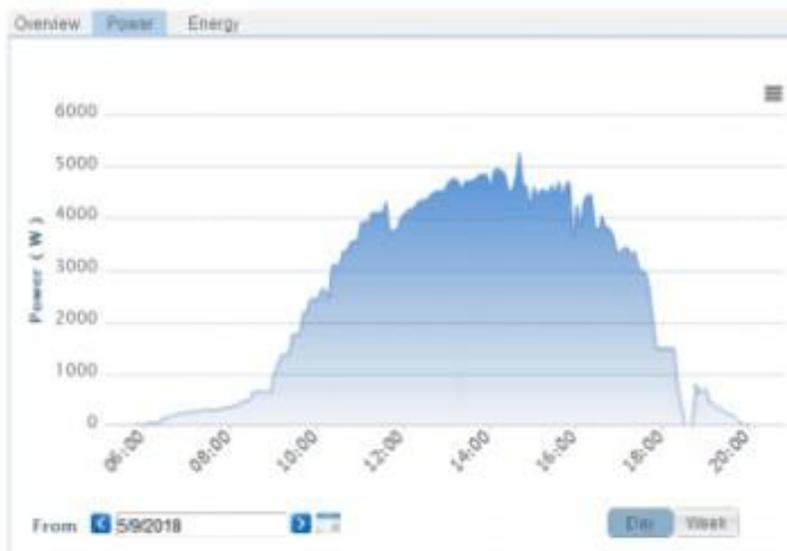
Case 7: The curve displayed on EnverPortal is jagged.
