EnverPortal Abnormal Issues & Solutions

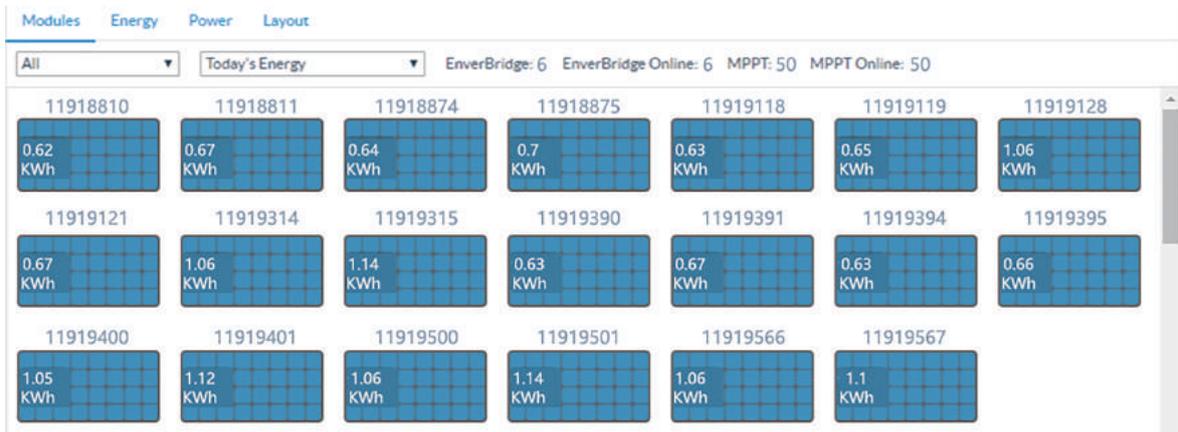
Case 1:

Enverportal shows that several microinverters generate less energy than others, and stop uploading data prematurely.

First, any shade or dirt on the PV module should be avoided.

If it doesn't help, please check whether these microinverters are working normally or it is a network problem. The steps are as follows:

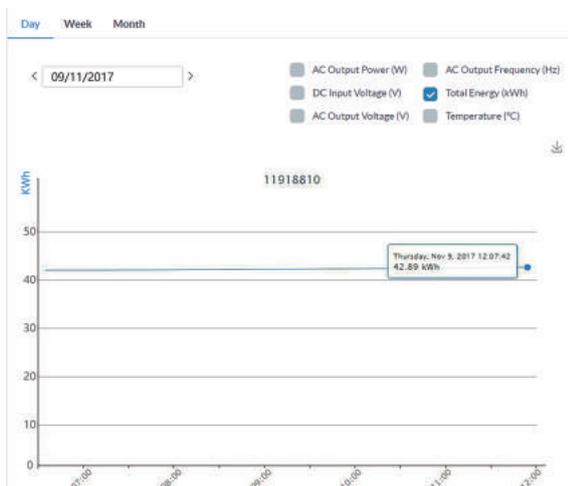
Picture 1

On the overview page of the monitoring system, click into one PV panel and select "Total Energy". Check the latest energy output value of the first day. Here in *Picture 1* it shows 42.89kwh at 12:07 on the 9th. Check the initial energy output value of the next day. In *Picture 2* it is 43.31kwh at 6:46 am. The results show that the microinverter was generating electricity normally on the first day, but the network communication had some problem for a certain period of time.

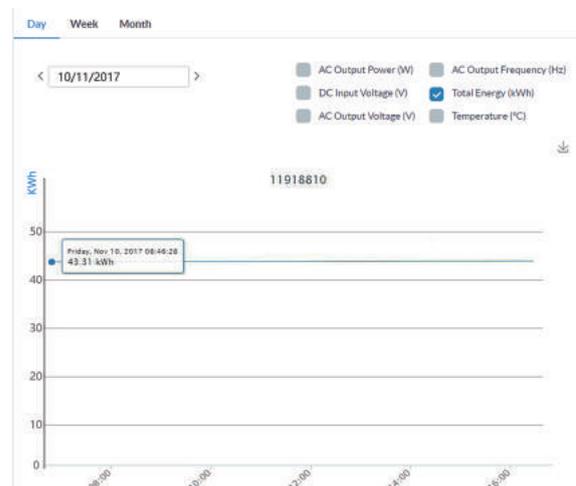
Picture 2

If the latest energy output value of the first day and the initial energy output value of the next day are the same, then it means the microinverter was not generating power normally during that period.

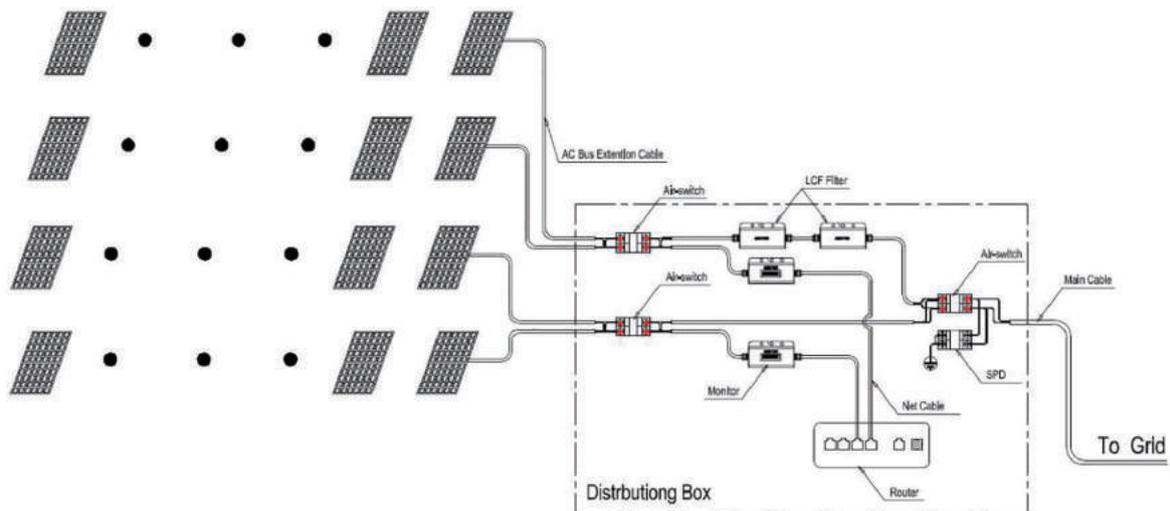
Incorrect wiring

Abnormal value is displayed on EnverPortal in energy generation of one or more panels, such as: negative value or more electricity generation than normal.

This case may be caused by the incorrect wiring in the PV power plant. The following wiring can cause abnormal power generation:

The case above mainly occurs when the single-phase system has over 20 PV panels. The main reason is the signal crosstalk between 2 EVB201s causes the data uploaded by EVB201s cannot be processed normally by the server, leading to abnormal data on EnverPortal or EnverView.

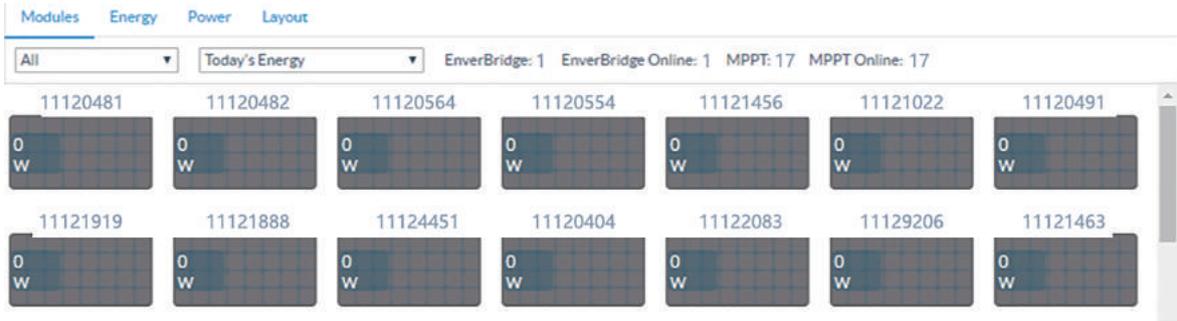
Case 3:

On EnverPortal it shows as below:

Please check if EnverBridge is correctly connected to the Internet. Refer to *Appendix 1* in the next page for detailed procedures of self-check.

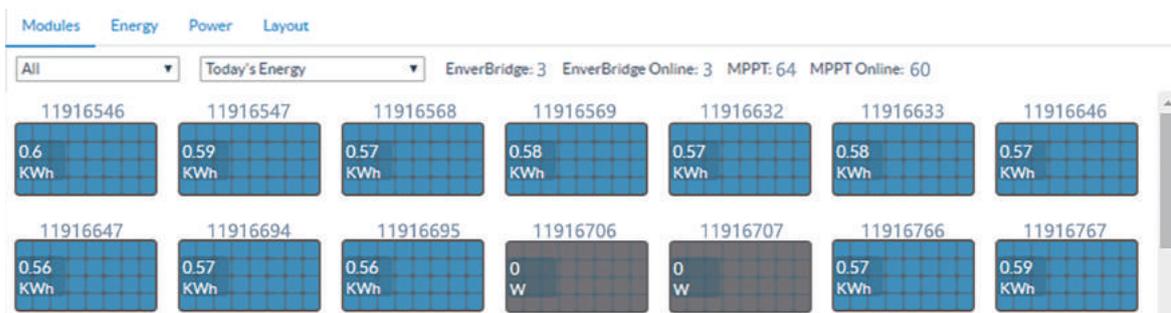
Case 4:

EnverPortal shows that some PV panels consistently generate 0 kWh.

First, if this microinverter’s LED light flashes red, please check whether the DC cables of the PV panel are finely connected. Try disconnecting the DC cables and wait for 10 seconds. Then reconnect them. Observe whether the green light flashes after 3 minutes. If not, please contact your installer or tech@envertec.com for more help.

If the green light is flashing and the microinverter is working normally, then please check the history report of that problematic microinverter. If this problem only occurs on that day, it could be due to an occasional communication fault. If the problem has lasted for a long time, the microinverter could have a malfunctional communication module though it is still generating power. Then please contact with your installer to get a replacement.

If the microinverter’s LED light flashes red (which is of high possibility) and the problem has lasted for a long time as seen in the history record, please contact your installer or tech@envertec.com.
